Manhole Inspection Summary

Manhole # S27M__036MH

Location Address: **838 Parkin St**

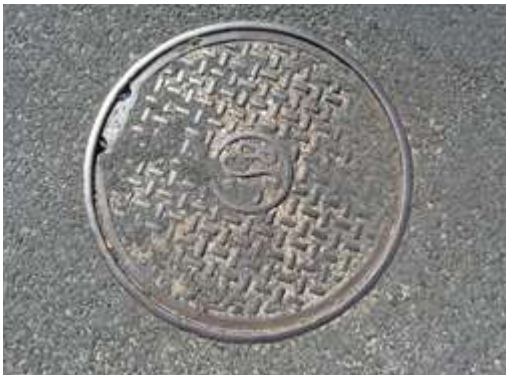
Cover View

Condition: **Sound**

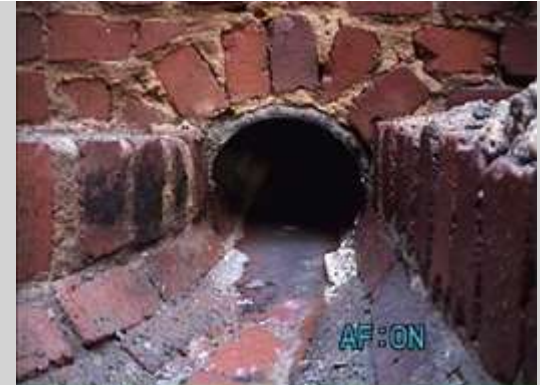
12 O'Clock Outflow

8 in. Circular Gravity Sewer
Pipe Out @ 12 O'Clock

Pipe Height: **8.4** (in.) Rod and Bar (Angled)
Pipe Material: **Clay** ☐ Pipe Lined
Invert Depth: **6.83** (ft.) Flow Characteristics: **Slow**
Deposits: ☒ None ☐ Mud ☐ Sludge ☐ **Debris** ☐ Grease
Silt Depth: **0** (in.) Deposits Extent:
Infiltration: **None** Pipe Seal Cond: **Sound**

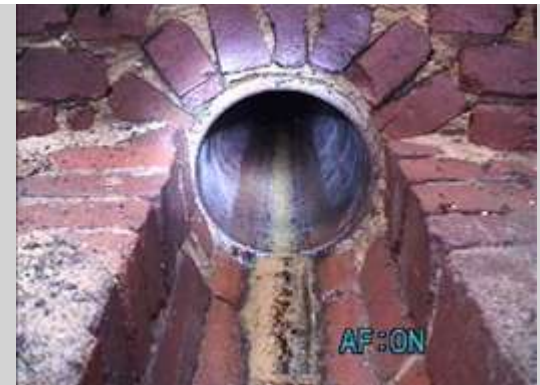
6 O'Clock Inflow

8 in. Circular Gravity Sewer
Pipe In @ 6 O'Clock

Pipe Height: **8.4** (in.) Rod and Bar (Angled)
Pipe Material: **Clay** ☐ Pipe Lined
Invert Depth: **6.16** (ft.) Flow Characteristics: **None**
Deposits: ☒ None ☐ Mud ☐ Sludge ☐ **Debris** ☐ Grease
Silt Depth: **0** (in.) Deposits Extent:
Infiltration: **None** Pipe Seal Cond: **Sound**
